CITY OF KIRKLAND

PLAN NO. CK-R.14

EDGE RESTORATION
DETAILS

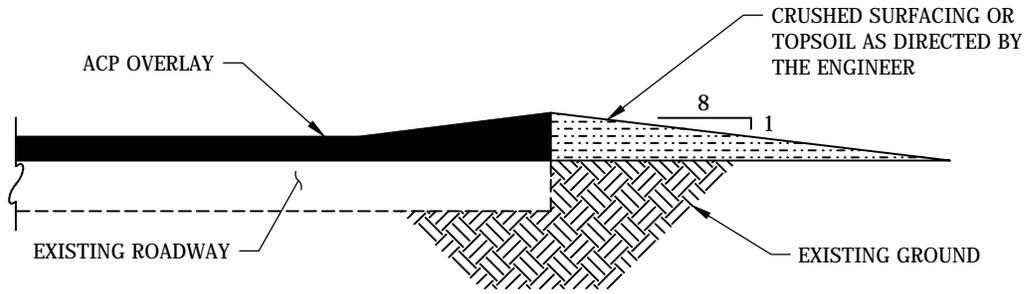
WITH THICKENED EDGE

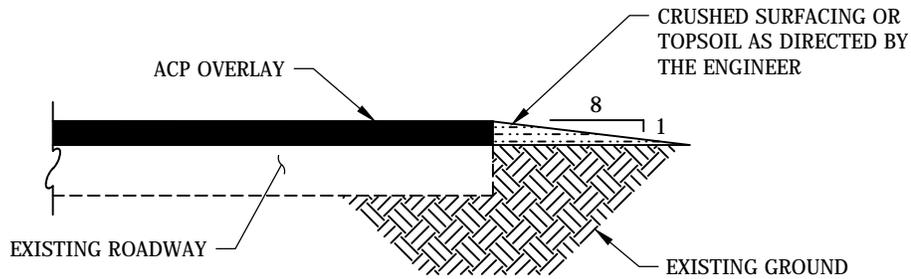
WITHOUT THICKENED EDGE

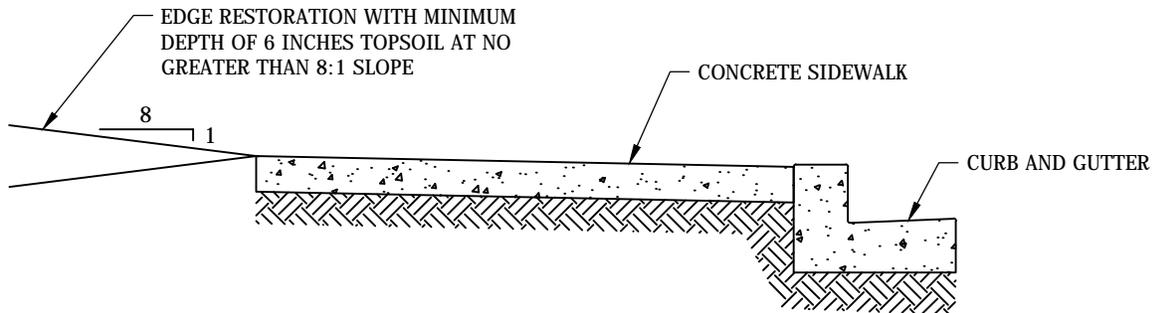
EDGE RESTORATION BEHIND CONCRETE SIDEWALK
